The North Ipswich Roundhouse

Greg HALLAM

Hallam, G. 2011 The North Ipswich Roundhouse. *Memoirs of the Queensland Museum – Culture* 5(1):137-161. Brisbane. ISSN 1440-4788.

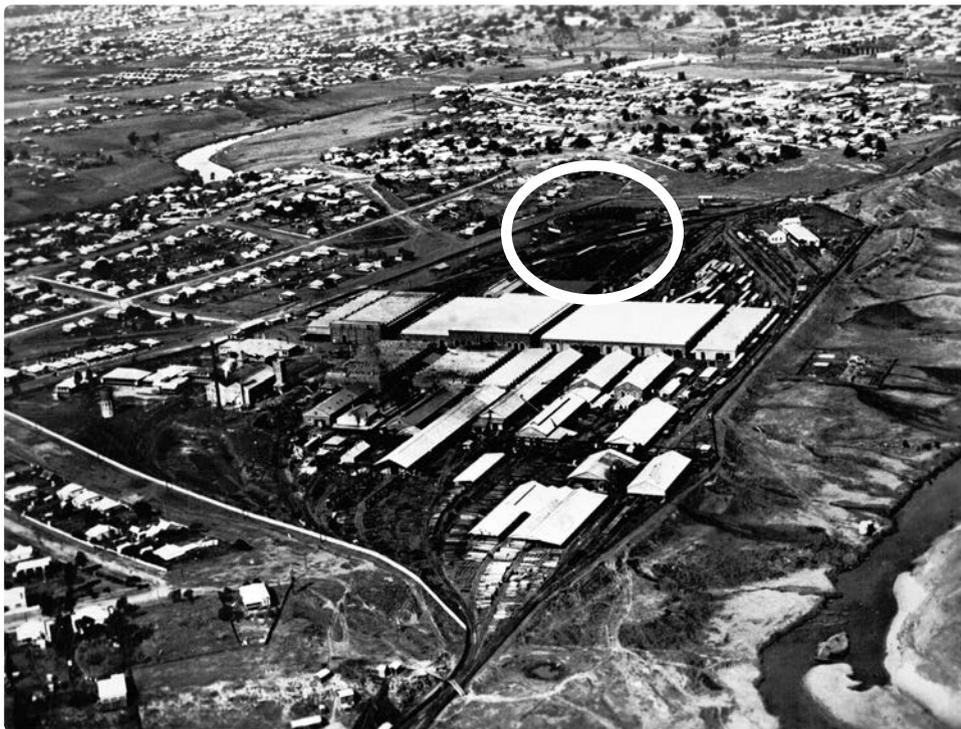
FIG. 1. The Ipswich Railway Workshops looking south, showing the Roundhouse to the mid-background of the photo c.1964. Image courtesy Keith McDonald.

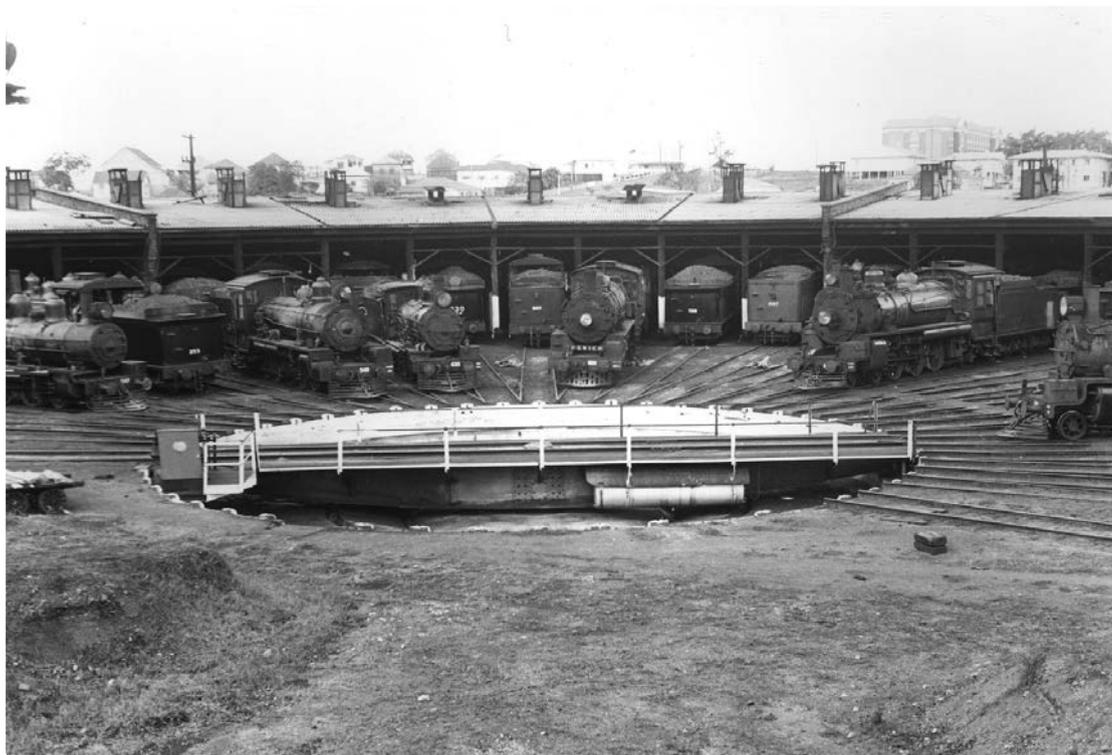
FIG. 2. The Roundhouse with the turntable in the foreground. Note the doubling of the locomotives on the roads, 1965. Image courtesy Brian Martin.

The central point of the Roundhouse design was a series of short tracks radiating from a central point (Figure 2). This enabled a rotating length of track to be moved in a 360° circle and in doing so gave access to other lengths of track used for the storage of locomotives. These lengths could then be placed under a form of building/shelter to provide cover for locomotives in storage and for workers involved in their maintenance. North Ipswich Roundhouse was officially described as being a 'semi-circular engine shed', having 30 'roads' under cover. Access was gained to these lines from an air operated turntable. Each 'road' was approximately 40 metres in length, with the last 19 metres of the 'road' being under shelter. The entire Roundhouse building was built off a radius

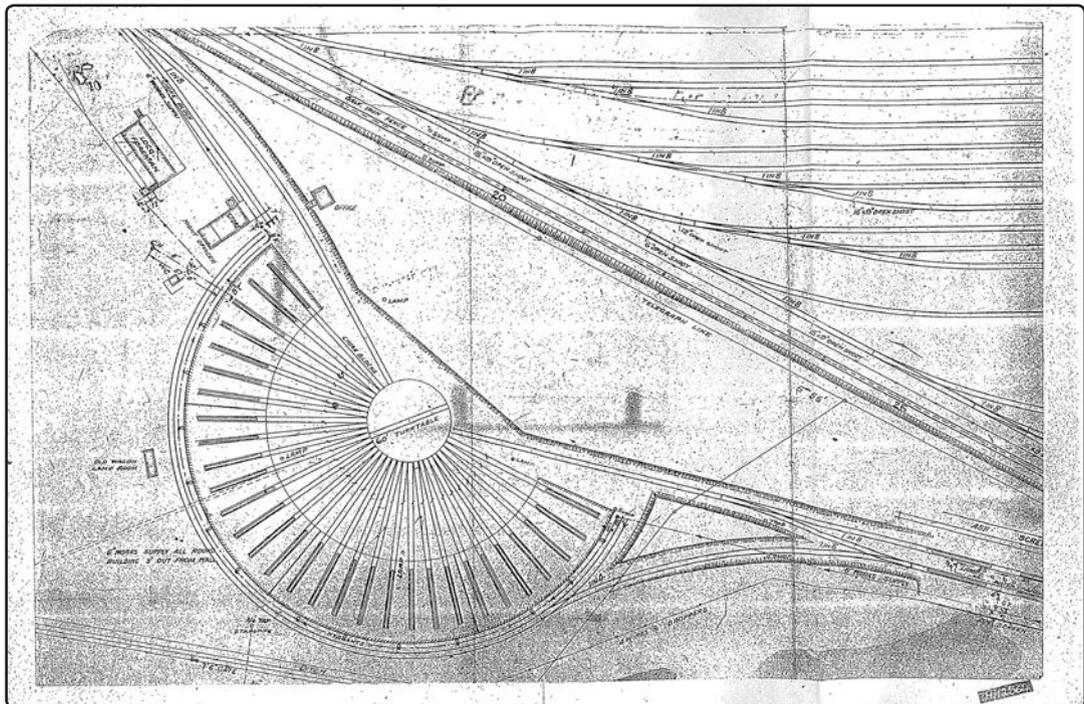
FIG. 3. North Ipswich Roundhouse, 1920 (QSA A/12564).

of 60 metres from the centre of the Turntable (Figure 3). On-site inspection in 1993 showed that at its farthest extent the Roundhouse was 100 metres across (from the end of No. 1 road, across the Turntable to the end of No. 30 road). The Roundhouse was divided up into four bays, each bay holding seven roads. Inspection pits were recessed into the floor to allow for examination of the locomotives below rail level. Each pit was approximately 13 metres in length, and was constructed of concrete which was recessed 1.3 metres below rail level. The Roundhouse was roofed by sheets of corrugated iron, sloping from the rear of the structure forward to the entry roads. Ventilator shafts were mounted on the roof to allow for the escape of smoke during the lighting up procedure for locomotives housed in the shed. Interior supports inside

The turntable ran on a single circular rail mounted in the turntable pit. The base of the pit was concrete. The turntable itself revolved around a large single pivot point running through the decking, set at a centre point in the concrete pit as seen previously in Figure 3.

The major structures within the roundhouse environment discussed so far have mainly been associated with locomotive operations. A comparison of Figures 3 and 12 shows that initially the majority of buildings provided in the early years of the Depot were administration or store buildings. Two of these buildings in particular appear to have been important from the opening of the Roundhouse, the Loco Foreman’s Office and Loco Store. In an aerial view of the Roundhouse (Figure 18), the two larger buildings of single story construction at the south end of the entry/exit road were the Foreman’s Office and Store.

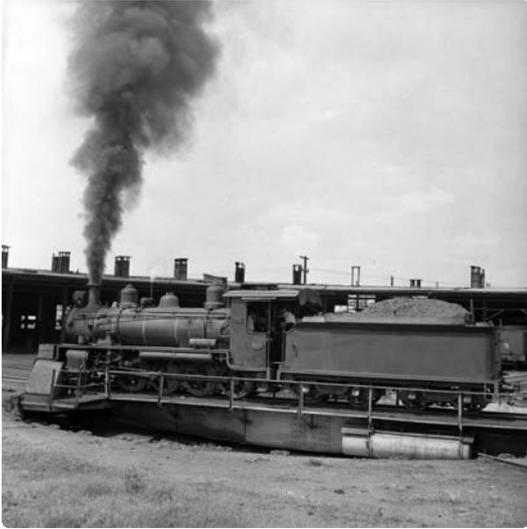
FIG. 4. C17 class locomotive No. 803 at Ipswich Roundhouse, 1969. Windows visible on left hand side. Image courtesy TWRM/QR.

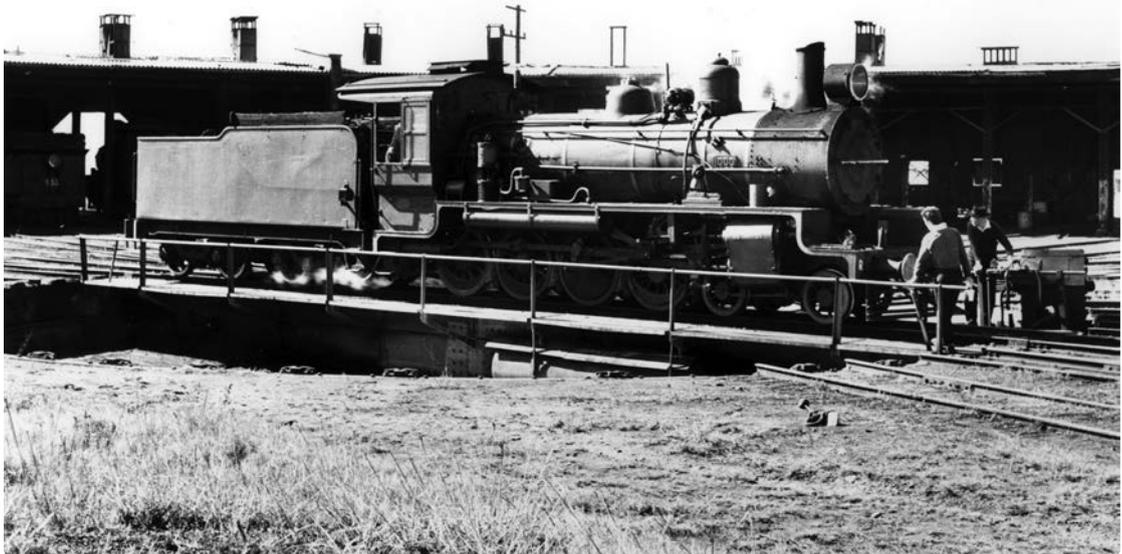
FIG. 6. The Roundhouse showing the C17 Class locomotive on the turntable, c.1969. Note the location of the motor and control point on the Turntable. Image courtesy TWRM/QR.

The motor has now been in operation for four weeks and has so far worked well. Compressed air for driving is supplied from two reservoirs 2 feet 6 inches in diameter by 12 feet long fastened underneath floor of table, these being charged by means of a standpipe having ordinary Westinghouse couplings which can be attached to train pipe coupling of any engine under steam which is on the turntable. The reservoirs are of sufficient capacity when once charged, for 3 revolutions of the turntable. The turntable is 60 feet in diameter and makes a complete revolution in one and a half minutes (QSA A/24236).

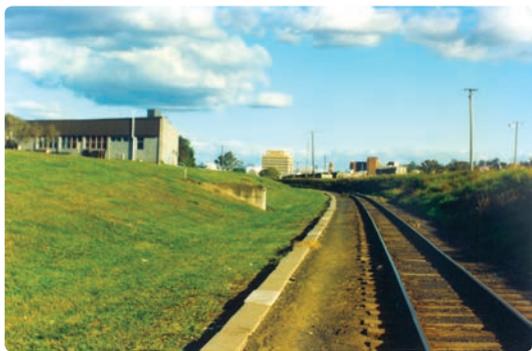
FIG. 7. The only remaining evidence of the coal stage – a concrete pier base, 1993. Photo Greg Hallam.

At present the only physical trace remaining of the coal stage is a concrete base, or pier, at the one kilometre mark on the connecting line. This base is set recessed into a sloped grass embankment. Three metal rods project upwards from the base (a distance of 45cm). Full dimensions of the base have not been recorded but the approximate dimensions are of a height of 1.5 metres, with a width 1.3 metres. The concrete base extends approximately 3 metres into the grass embankment. A railway kilometer marker (a white rail; marked '1km') is at the Western end of this object. Figures 7 and 8 show the remaining concrete base at its location in 1993. Figures 9, 10 and 11 show the coal stage when it was still a functioning part of the railway environment of North Ipswich. The coal stage acted as a refueling point for locomotives attached to the Roundhouse.

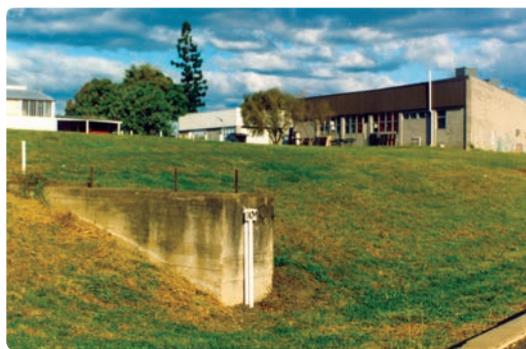
FIG. 8. Close up view of evidence of the coal stage – a concrete pier base, 1993. Photo Greg Hallam.

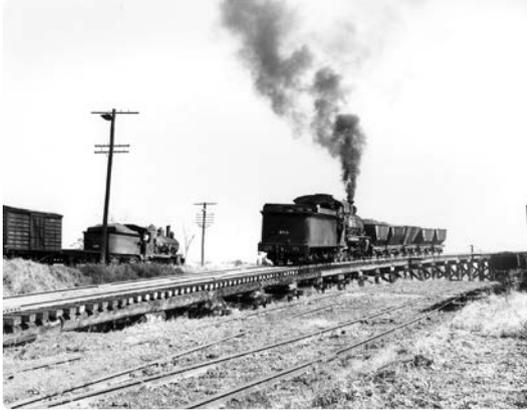
FIG. 9. A C17 Class locomotive propelling wagons up the coal stage prior to discharging the hoppers, c.1969. Image courtesy TWRM/QR.

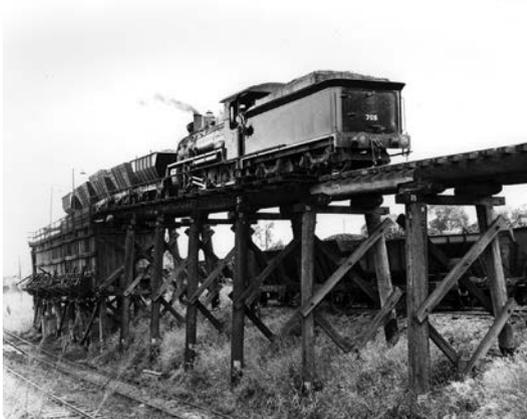
FIG. 10. A C17 Class locomotive positioning coal hoppers above discharge bins prior to transferring coal into the bins, c.1969. Image courtesy TWRM/QR.

Regular replenishing of the coal and water supply was needed in the running of steam locomotives, to maintain adequate fuel and water levels. A gravity feed system was used to deliver coal to the tender of locomotives. Coal was stored in a series of bins, and was then fed into the locomotive tender by chute. Transfer of coal into the bins was undertaken by a locomotive propelling a rake of loaded coal hoppers up a rising track. This track was supported by a series of wooden piers (28 in number) on a rising gradient. (Figures 9 and 10). The coal discharge bins were located at the end of this elevated track (Figures 10 and 11). The operation of coal loading into tender was controlled by the steam locomotive's fireman. As the figures show, the method of coaling a locomotive could be a hazardous operation. The departing locomotive receiving a tender of coal from the elevated coal stage had to be positioned so that coal would discharge into empty areas of the tender. It was also an operation that generated a large amount of dirt and dust. From reconstruction from available photographs it would appear that the maximum height of the coal stage above ground (rail) level was 10 metres. The stage itself was constructed of hardwood timber piers and the discharge bins were milled and sawn timber. Handrails and walkways either side of the 'top' of the coal stage acted as a safety feature for the person responsible for the operation of the stage. Safety platforms were also provided at staggered intervals so that maintenance workers could move out of the path of shunting trains advancing up the elevated structure.⁵ The coal stage was also built on a rising trestle, situated on a curve, making for difficult operation for the engine crew. The coal stage appears to have been built between 1923 and 1925 to replace a smaller structure (QRAR, 1925:22-23).⁶ The photographic evidence indicates that there were nine coal shutles available for the delivery of fuel into the locomotive tenders.

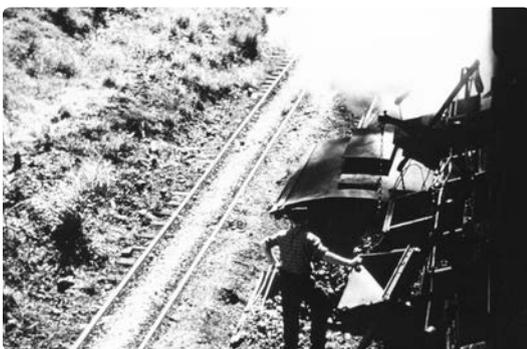
FIG. 11. Coal being discharged into a locomotive tender from coal bins, c.1963. Image courtesy TWRM/QR.

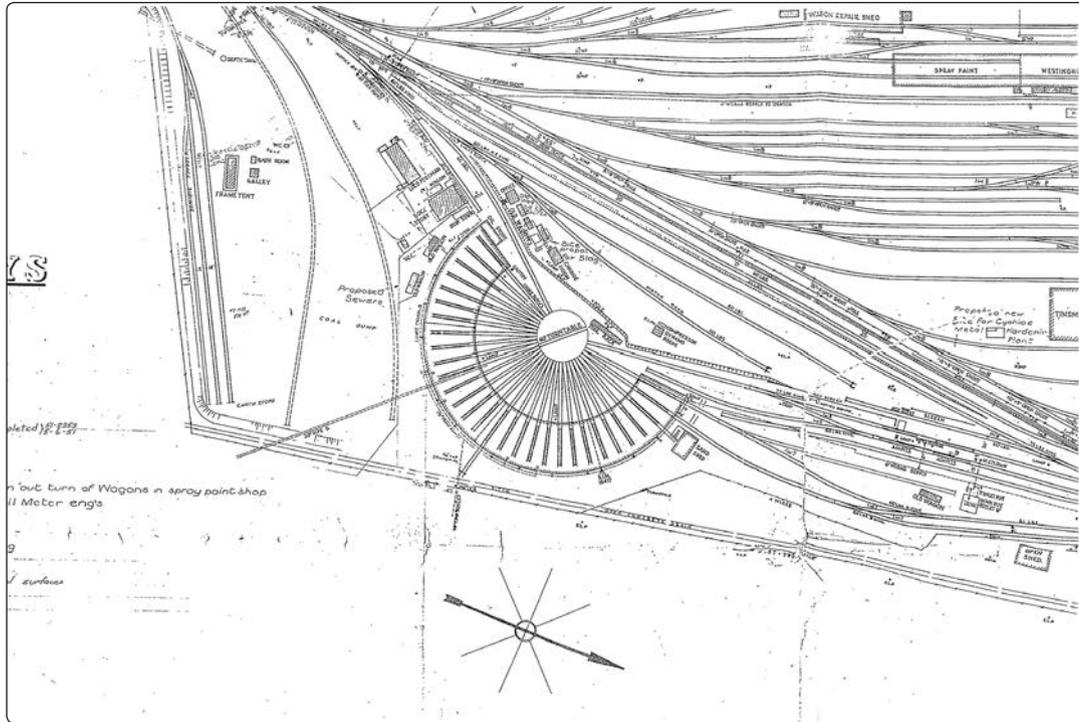
FIG. 12. Details from Queensland Railways – Ipswich Workshops Yard, Section of Roundhouse and associated yards, 1968. Queensland Rail Archive.

An extra ash pit and water column was also provided at the southern end of the coal dump siding (Figure 12). This was included at the request of a deputation from the Engine Drivers, Firemen and Cleaners Association:

that these structures were made from weatherboard and corrugated iron roofing. The Loco Foreman's Office was 16 x 6 metres and the Loco Store was 16 x 16 metres. As originally built the Loco Store also contained an extension for the use of the Night Officer. Figure 19 shows the office building that existed until the closure of the Roundhouse, and the 1968 plan (Figure 12) shows the newer office drafted in.

A smaller office existed opposite the Loco Store, until the 'new' office was provided. In Figure 12 the building drawn behind the telegraph pole is a change room. Amenities such as the change room were much later additions to the Roundhouse. Figure 12 also shows that old wagons were stored at various locations. These were mostly condemned goods wagons, removed from bogies and used for storage purposes. To the south east of the Foreman's Office in between the storage sidings and Coal Dump were a small group of outbuildings. These

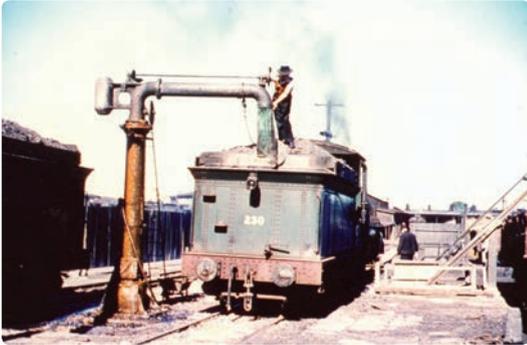
FIG. 13. Showing water crane in operation and fireman supervising water flow into the tender. Image courtesy TWRM/QR.

hardwood lamps, with enamel lampshades, were provided for night operations. Illumination was supplied by incandescent electric light. The operational activity in the ash pit location around 1962 can be seen in Figures 13-18.

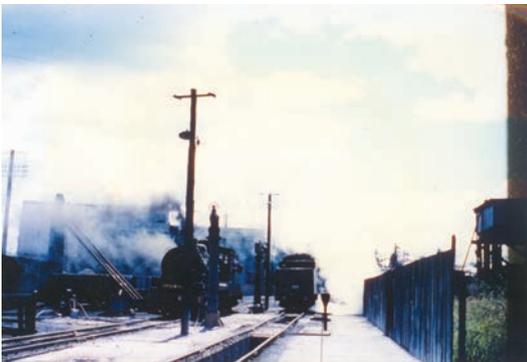
FIG. 15. Two locomotives, B18 1/4 and C17 Class taking on water. To the right of the leading locomotive an elevated water tank and lamp posts can be seen. Ash screens and blowdown board are to the right and ash pits in foreground. Water cranes are visible in the mid-ground. To the left there is an ash hoist with a dump wagon. Smaller water hydrants can also be observed with hose attachments for dampening down ash. Image courtesy TWRM/QR.

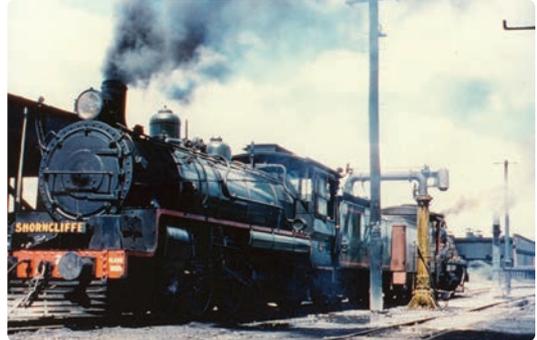
FIG. 14. Ash hoist pulley system is observable in the background. The locomotive is taking on water. Image courtesy TWRM/QR.

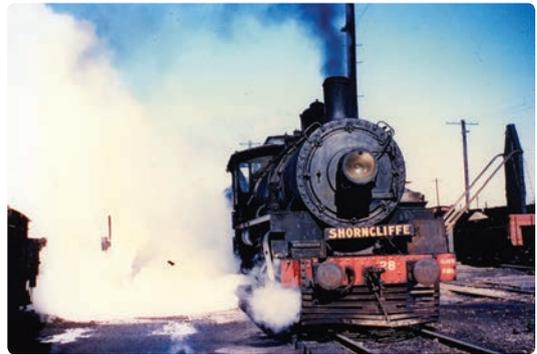
FIG. 16. A locomotive is seen blowing the boiler down near the "blow down" screen. This was done to clear the boiler of scum that formed on top of the water level in the boiler. Image courtesy TWRM/QR.

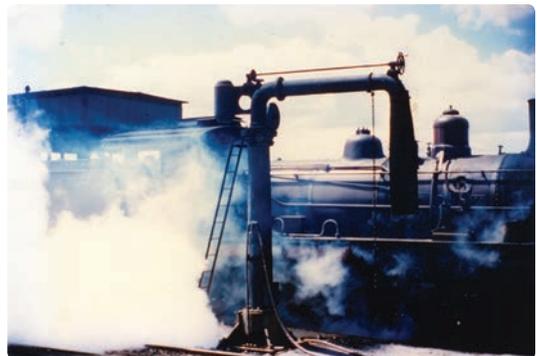
FIG. 17. A locomotive blowing down at ash pits, showing a water crane in the foreground and an elevated water tank in the background. Image courtesy TWRM/QR.

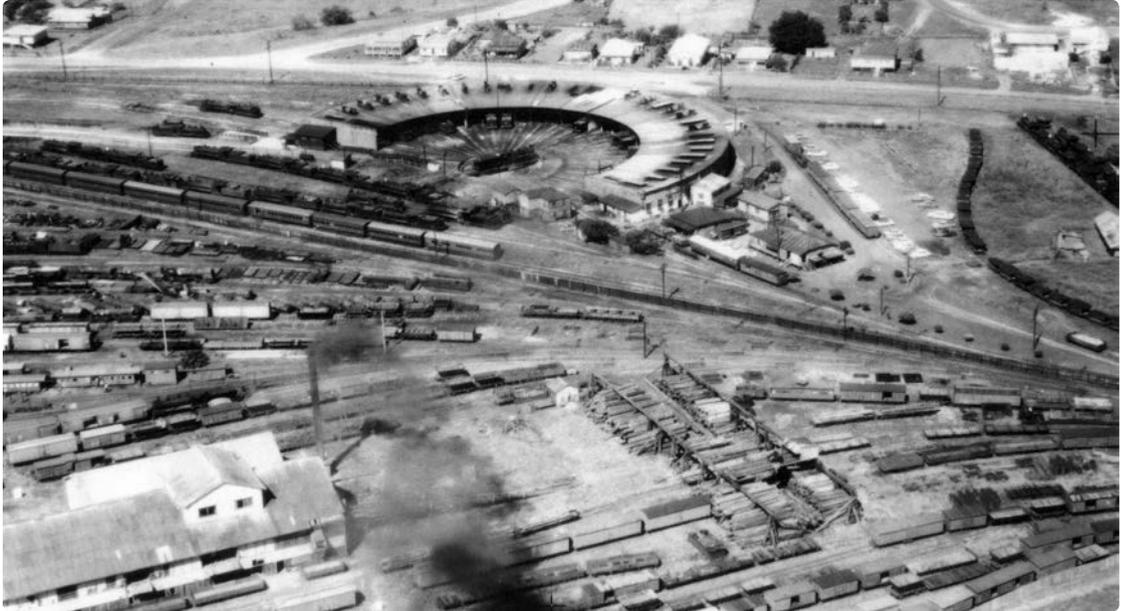
FIG. 18. An aerial view of the Roundhouse, showing a group of buildings at the entry/exit to the turntable. Image courtesy TWRM/QR.

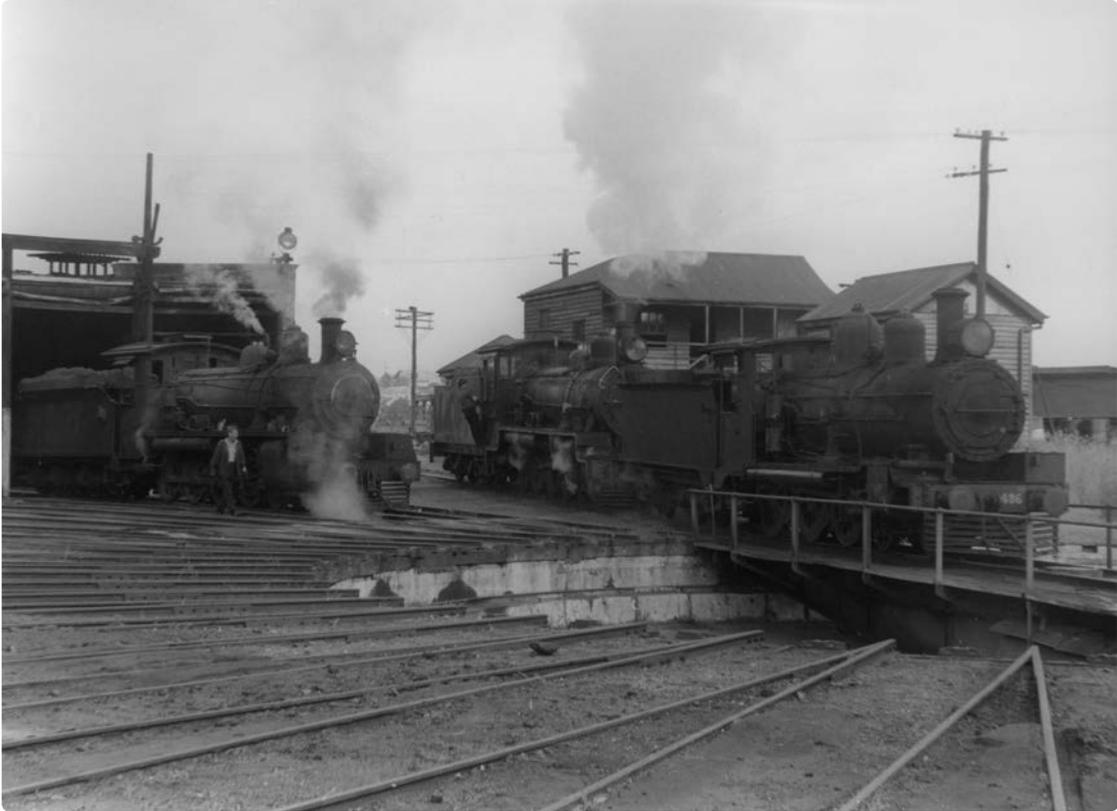
FIG. 19. The Roundhouse turntable, showing C17's No. 763 and No. 934 shunting PB15 No. 486 on the turntable with 'New Office' change room in background, c.1970. Image courtesy Brian Martin.

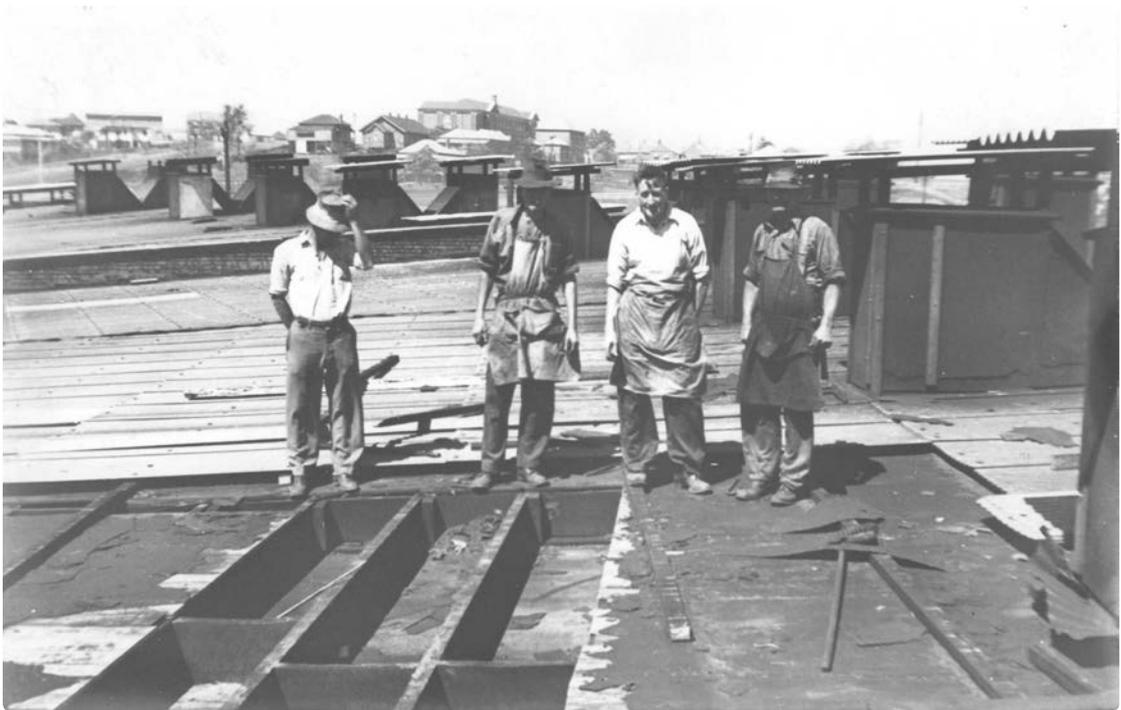
FIG. 20. The North Ipswich Roundhouse required maintenance for the steam locomotives and for the physical fabric of the place. The photo shows part of the roof receiving attention. To the rear of the work gang ventilators used to exhaust smoke into the air can be seen. A water proofing material was used underneath the metal covering of the roof. Just imagine this job on a hot North Ipswich day! Image courtesy TWRM/QR.

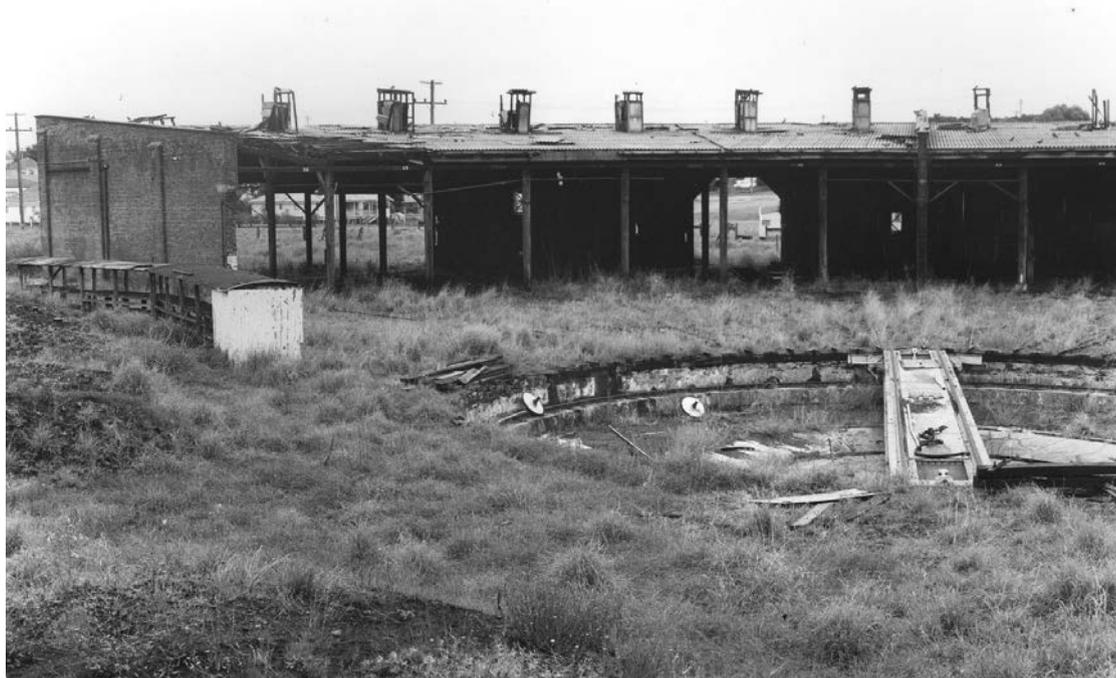
FIG. 21. The Roundhouse lying derelict following its closure. The stripped turntable, tool rack to the left (former tool box store) and roof ventilators are visible, 1974. Image courtesy Brian Martin.

Following its official closure, the site became derelict (Figure 21). Final demolition took place in July of 1978:

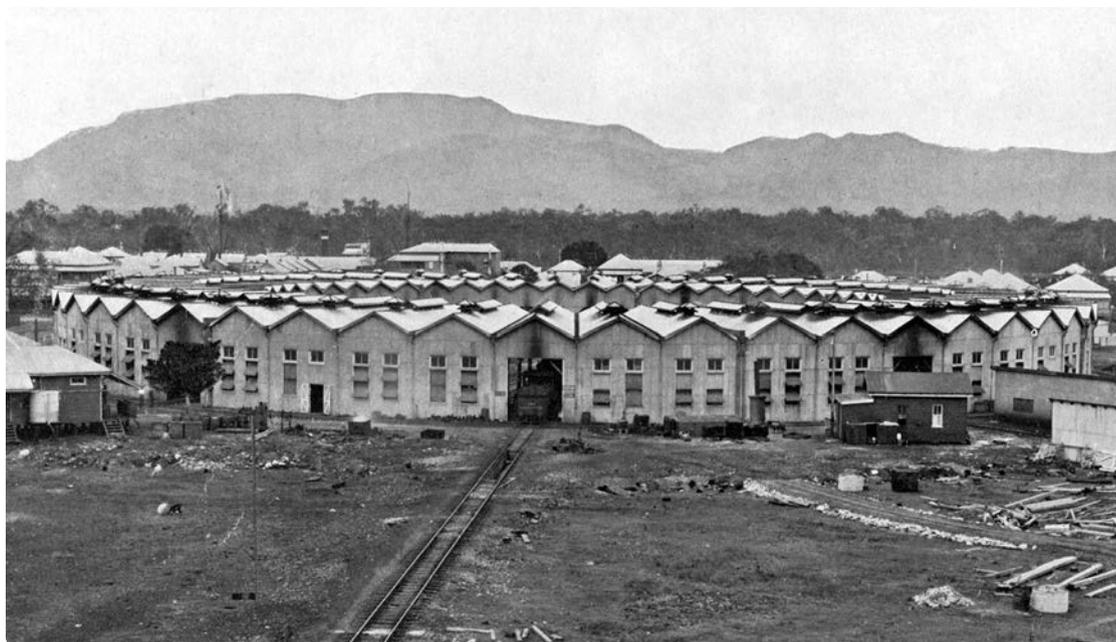
FIG. 22. Rockhampton Roundhouse c.1917 (QRAR, 1917).

This left the Rockhampton roundhouse (Figure 22) as the only extant example of a Roundhouse in Queensland.

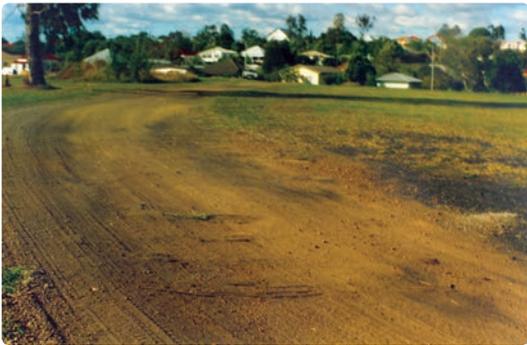
FIG. 23. Sleepers remaining in ground and coal dump siding, 1993. Photo Greg Hallam.

approximating a former siding into the Coal Dump and the main access line towards the Roundhouse and Turntable was still visible as tracks on the ground (Figures 23 and 24).

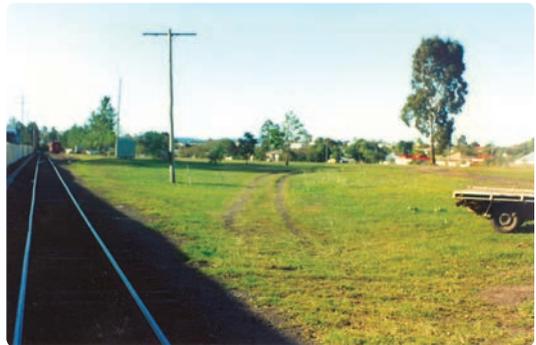
FIG. 24. Vehicle path in foreground approximating entry road to Roundhouse, 1993. Photo Greg Hallam.
