**Pandora Project Stage 2:  
four more seasons of excavation  
at the Pandora historic  
shipwreck**

by Peter Gesner

# INTERPRETATION OF SELECTED ARTEFACTS FROM THE PANDORA HISTORIC SHIPWRECK (1791)

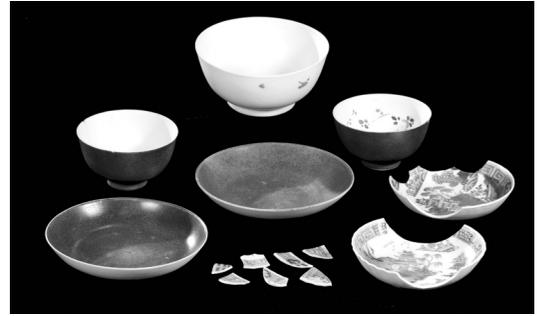
FIG. 446. Bowls and saucers of Chi'ing blue & white, Chi'ing powder blue and Canton porcelain.

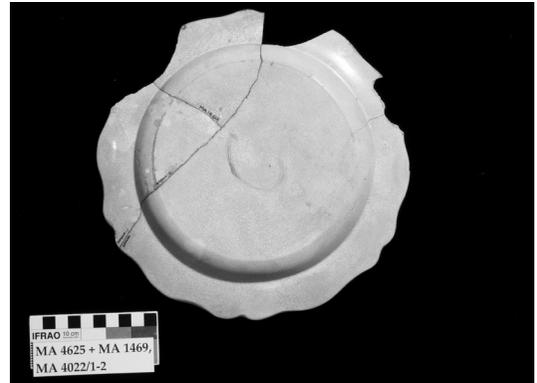
FIG. 447. Creamware plate, C letter scratch (MA4625).

From this deposition it is likely that they were being used by the commissioned officers – the three lieutenants – as well as by the warrant officers, who shared the wardroom mess area on the aft section of the lower deck (cf McKay 1992:54 dwg D2/6). An additional indication that they were used by the officers are the many examples of the letters C or W crudely scratched on the undersides of plates; therefore most probably indicating crockery used by, respectively, the commissioned officers and the warrant officers (figures 447 and 448).<sup>3</sup>

A significant proportion – approximately 28% – of this cream ware was clearly in use at the time of the wrecking, witness the wear marks made by cutlery on surfaces, as well as the letters (C or W) scratched on the base of some plates and platters.

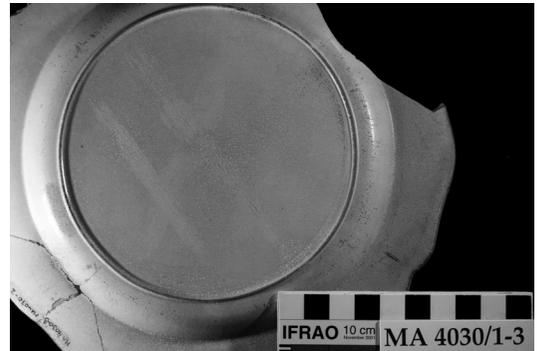
FIG. 448. Creamware plate W letter scratch (MA MA4030/1-3).

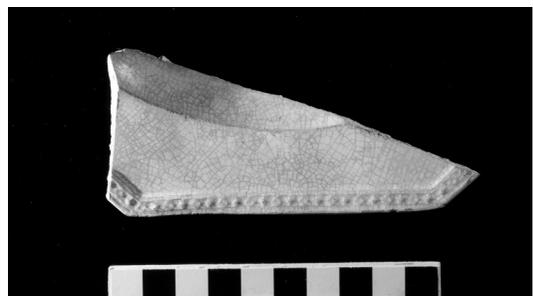
FIG. 449. Creamware beaded edge octagon (MA MA6305)

octagon' form plate sherd (MA6305) which was found in a relatively shallow seabed stratum in grid 107 – at X 20.25, Y 7.26, Z 100.24. Unfortunately this grid could not be excavated to any greater depth because of an obstruction that was encountered there formed by a large coil of hawser that had been nailed to the lower deck planking. Clearly, this obstruction had served as a definite delineation and a physical barrier between the lower deck and the underlying store on the platform deck, which lies in a deeper seabed stratum. Anything lying in shallower strata on top of the hawser and/or lower deck planks therefore must have been deposited from either a space on the lower deck – i.e. a cabin, pantry or cupboard erected there – or a space on the upper deck (i.e. the Great Cabin).

As already mentioned, all but one of the (round) plates from the *Pandora* are so-called ‘Royal pattern’; only one example is anomalous, i.e. MA6305, the fragment of an octagonal shape plate with a beaded edge. Another feature of differentiation is that some examples have a foot ring around their base. Clearly then it would seem that there were at least two ‘dining sets’ (dinner services) on board – one with and one without a foot ring. The ‘sets’ (or services) were likely made by different manufacturers

A third 'set' is possibly represented by the octagonal, beaded-edge plate (MA6305); although it is a little puzzling that only one sherd of this type has been recovered to date. As already mentioned, a number of shallow dinner plates, soup plates and serving platters have the letters C or W crudely scratched onto their base. These scratched letters probably reflect how the steward (or his mate) kept track of their intended use, i.e. the ones with a C were possibly intended for use at the captain's table and the ones with a W for use in the wardroom. Alternatively, the pieces scratched with a letter C may have been intended for use in the wardroom by the lieutenants (i.e. the commissioned officers) and the ones scratched with a W for use by the warrant officers. If the latter case applied, the captain may have used another dining set – e.g. the octagonal-shaped, beaded-edge type – which would have been

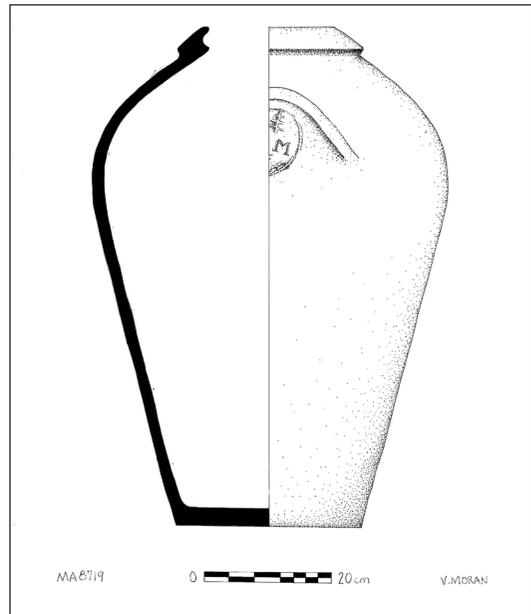
FIG. 450. Artefact drawing of olive oil jar MA8719/1 Drawing by Viv Moran. Queensland Museum.

Object record no. MA8719 (see figure 450) – an earthenware olive-oil jar with a narrow base, wide shoulders and a small rolled collar-like neck – was located in grid square 208. This is the fourth olive oil jar recovered from the bow area of the wreck to date. It is thought that at least six such jars were on board at the time of the voyage. This jar is identical to MA138 and MA139, the two jars recovered from the wreck during the museum’s expeditions in the 1980s (Campbell and Gesner, 2000: 109) and it is also very similar to MA3, which was raised by the wreck’s finders in 1977.

All of them are stamped with the initials ‘TMF’. They are unglazed and are wheel-thrown in two parts and have a flat base, with the sides flaring out upwards to a rounded shoulder. The neck is topped by an everted rim which has an internal, recessed ledge to accommodate a lid.

These (wheel-thrown) containers are on average 775mm high and 556mm wide at the shoulder. The jars were made in two parts; both are joined

at the shoulder. They have a flat base with an average diameter of approximately 282 mm and outward tending sides towards the shoulder. The shoulders are capped by two rudimentary, crescent shaped 'ridges'. The neck of the jar is truncated and topped with a rolled rim with an internal ledge to receive a lid. The lid was also made of terracotta, and had three finger holes arranged in a triangle to facilitate its removal. To avoid spillage, it is possible that the lids were sealed with wax or similar material before being tied down. However, no lids belonging to, nor any traces of wax have been found on any of the four jars recovered from the *Pandora* to date.

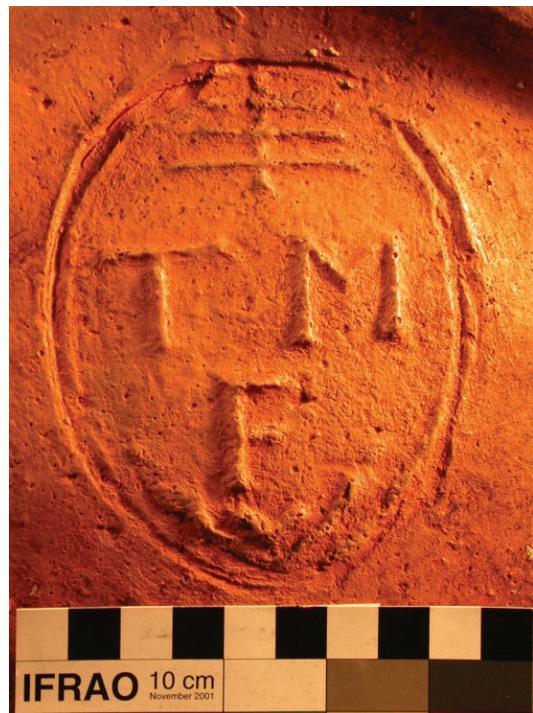
FIG. 451. ‘TMF’ Producer’s stamp

The ‘TMF’ stamp (see figure 451) – placed between a three-barred cross motif above and an olive tree twig below – is on plaques placed under two arched ridges on opposite sides of the shoulder. The stamp is regarded as the mark of the primary oil producer rather than the maker of the jar. The identity of the producer has yet to be established; however it has been convincingly argued that the jars originated in the Italian province of Tuscany, in the vicinity of Lucca or Montelupo (Coleman, 2004:6).

Capping the shoulder on two (opposite) sides are crescent-shaped vestigial ridges which were initially identified (erroneously) as 'handles' (Campbell & Gesner, 2000: 109). Upon further consideration however, 'handles' of this kind have been regarded as unsuitable to function as a grip. It was found that the jar was encased in a wicker base, for stability, which had two loops to provide a means for two or more men to lift a full jar – containing a 265 lb jar of oil – with a wooden bar placed through lifting loops; the basketry also served as cushioning or protection against possible impacts in a ship's hold. The arched vestigial ridges were primarily to protect the producer's stamp against damage during handling or shipping (Coleman, 2004: 138).

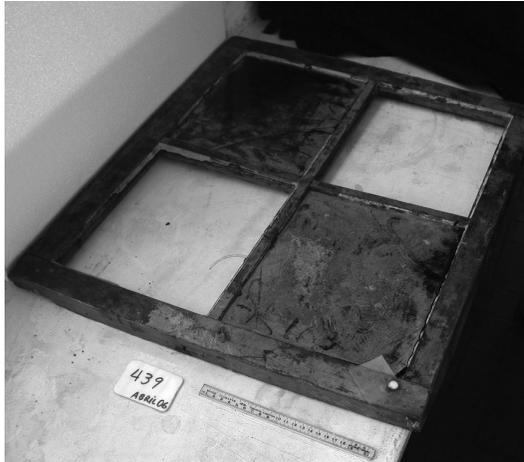
FIG. 452. A square frame from HM Sloop *Swift* (1770–four pane configuration – possibly for a cabin door). The 'rebates' within which the pane were set is clear in the spaces without panes; it is evident the panes had been installed as the putty holding the pane in place within the 'rebate' is evident (*Swift* #06/439) (Photo: Courtesy Dolores Elkin, PROAS, *Instituto Nacional de Antropología y Pensamiento Latinoamericano*, Buenos Aires).

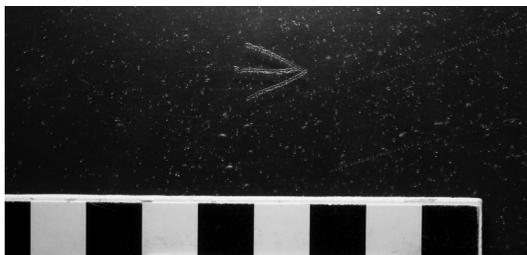
FIG. 453. Example of 'neat' broad arrow.

and pane fragments, which clearly show neat examples of arrows as well as cruder attempts suggesting application by more than one person. It is assumed the neat broad arrows are from panes that were installed when the vessel was being built or re-fitted in a dry-dock; cruder examples may reveal panes that were fitted as part of running repairs, i.e. while the vessel was at sea, the broad arrow possibly being scratched into the panes just before it was repaired, with the carpenter/glazier probably using a piece of gun flint to scratch the required broad arrow mark (see figure 453).

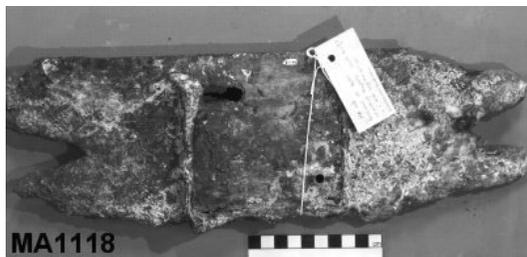
FIG. 454. Door stile fragment with outline of latch lock

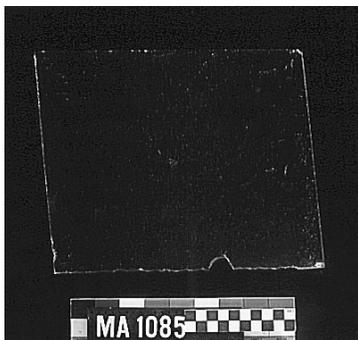
FIG. 455. Rhomboid pane.

Among the range of glass panes recovered from the *Pandora* to date, eighteen are more or less complete, i.e. wholly intact panes which are either rectangular or rhomboidal (Table 127), while a further eight registration numbers comprise 'near' complete ones, i.e. where the fragment

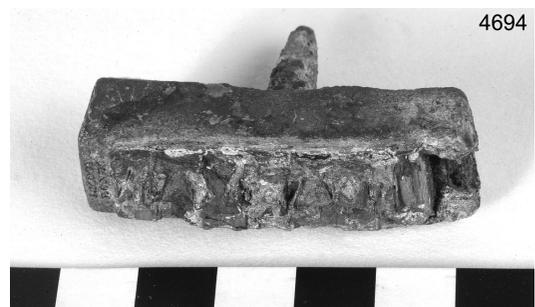
FIG. 456. Larkan's name stamp (MA 4694) recovered from grid nos. 87/89 during the 1996 expedition.

Documentary evidence has not yet been found to indicate that name stamps of this type were officially issued to naval officers – this would provide an unambiguous explanation that Larkan had the stamp for official use, i.e. it was associated with his professional responsibilities as the first lieutenant. Most probably then, it was for private use and he therefore kept it in a portable desk. Unfortunately none of Larkan's private correspondence appears to be extant.

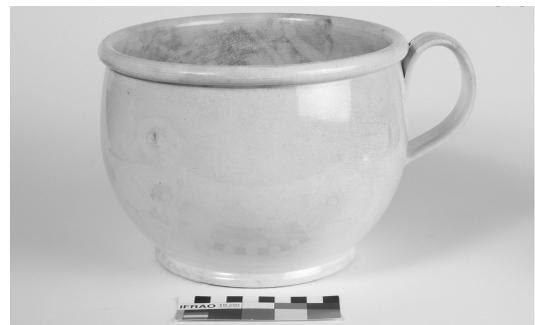
FIG. 457. Associated chamber pot (MA 4578) recovered from grid nos. 87/89 during the 1996 expedition.

professional items (figure 457), recovered from this area are therefore directly attributable to John Larkan.

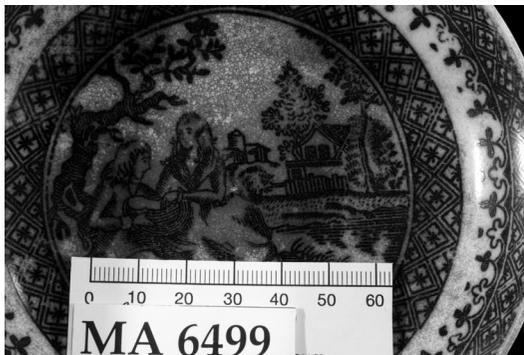
FIG. 458. Examples imitation 'china': a blue & white transfer printed refined earthenware saucer (MA 6499)

Chinese porcelain was much in demand in mid/late eighteenth century Britain. At the time of the *Pandora's* voyage, it was still being imported in appreciable quantities from the Far East, even though by 1780 British potters, especially in Staffordshire, were manufacturing imitation 'bone China', transfer-printing refined local earthenware and manufacturing 'China-like' cream-wares and blue transfer-printed wares (Miller 1980: 3-4). Examples of real Chinese porcelain (MA4854-9) have however also been recovered from the lieutenants' store area indicating the *Pandora's* lieutenants also used finer (presumably more expensive) crockery in addition to British imitations of 'china' and refined earthen-wares such as blue transfer printed ware, as well as 'cream-coloured' ware (See figures 458 and 459 both from wardroom area/lieutenants' cabins (Grids 87+70)).

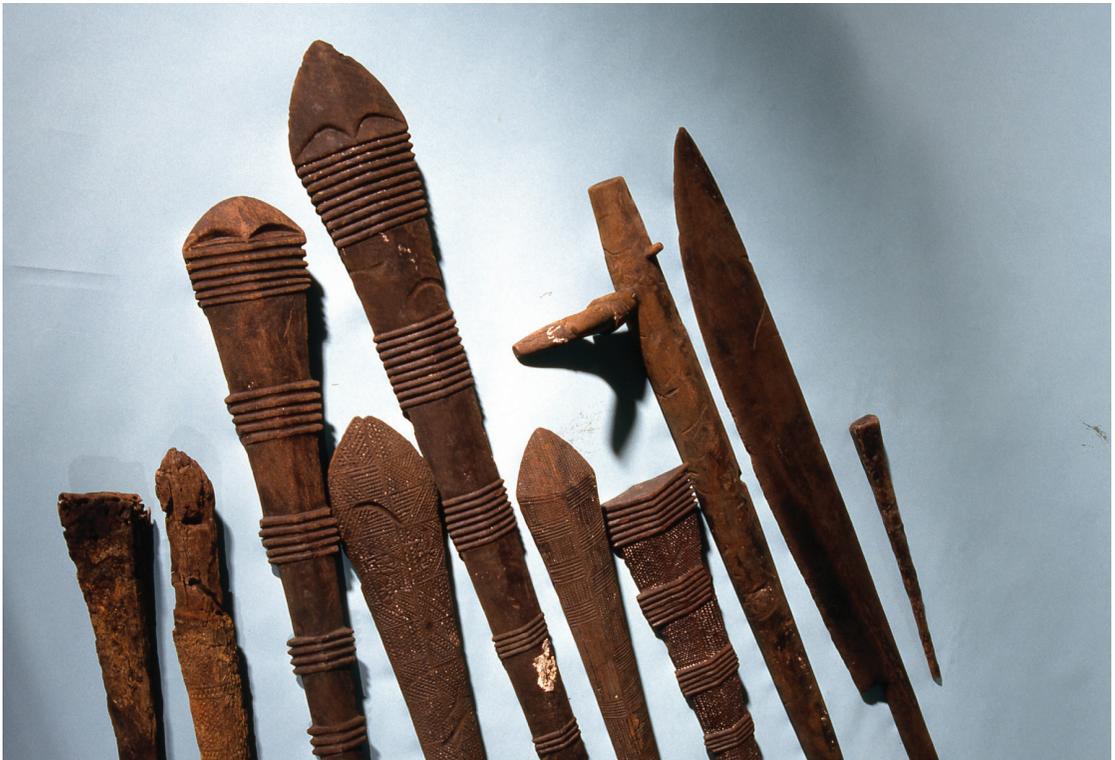
FIG. 460. A collection of war clubs from the *Pandora* shipwreck.

The clubs of the people of this isle [Eua, one of the Tonga Group] were of an infinite variety of shapes, and many so ponderous [heavy] that we could scarce manage them with one hand; the most common form was quadrangular, so as to make a rhomboid at the broad end, and gradually tapering into a round handle at the other. But many were spatulated, flattish and pointed; some had long handles...by far the greatest part were carved all over in many chequered patterns... (Thomas & Berghof 2000:238)

It would seem Forster was describing an 'apa apai'.
